ILLINOIS ENVIRONMENTAL PROTECTION AGENCY

Re: Dixon Iron and Metal - Dixon
LPC# 1030205178 – Lee County
SF/Tech

DIMCO
78 & 76 MONROE AVE.
DIXON, IL 61021

SOIL BORING /
SAMPLE LOCATIONS

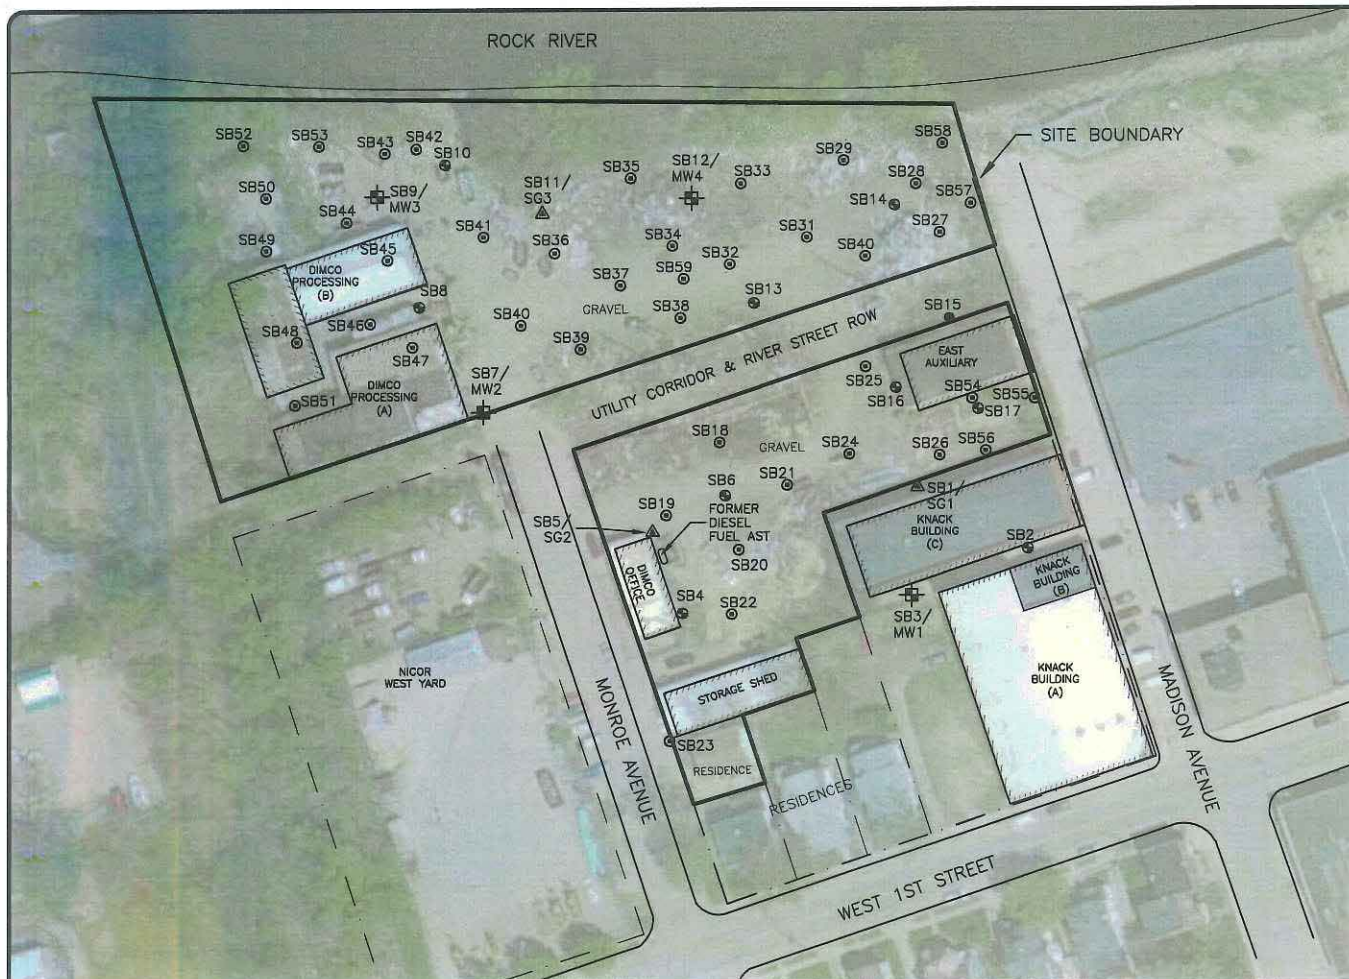
FIGURE:
2

In May, June, and July 2018, Illinois EPA conducted sampling activities as part of a Brownfield Redevelopment Assessment at the DIMCO site. During these inspections, a total of 54 soil borings were completed as well as the installation of five groundwater-monitoring wells. From the soil borings a total of 105 samples were collected for laboratory analysis. Analytical results indicate that shallow soils throughout the property are impacted with significant concentrations

of SVOC's, metals (antimony, arsenic, chromium, lead, mercury, and selenium), and PCB's. Levels of PCB's in the soil were detected at 7310 ppm. A copy of the analytical results and a summary of the PCB results are attached to this referral.

A significant amount of data has already been collected as part of previous investigations on the DIMCO site that indicates that Removal Management Levels have been exceeded. Access to the property remains somewhat restricted, however many hazards are present. In addition to the contaminated soil there also remains a risk due to the presence of several drums within a dilapidated building on the property. For those reasons, Illinois EPA would like U.S. EPA to consider a time-critical removal action.
